Enclosed Space Problems on Ships

'Our View'

Enclosed Space Exercise No 1 (double bottom)

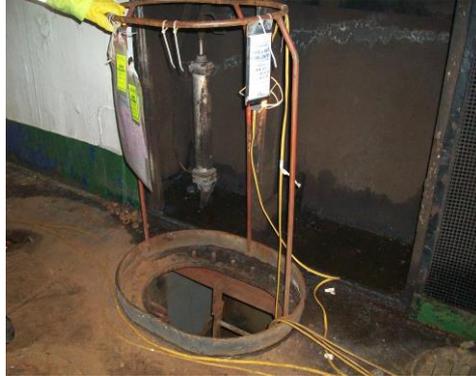
The exercise began with the rescue crew setting up a tripod and winch system on the upper deck above the access point into the hull. The entry hatch was oval in shape and measured approximately 420mm x 600mm

Plate 1: Entry Hatch

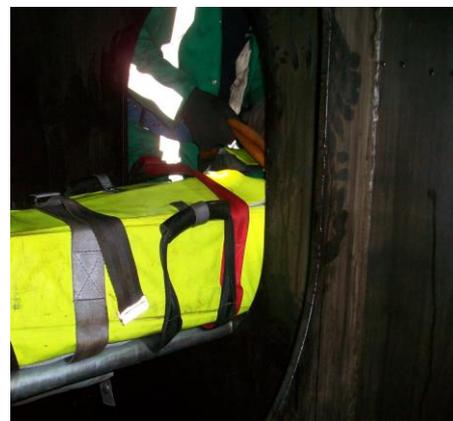
From this point the rescue crew (3 men) entered and travelled through the hull to the entrance to the double bottom, which was of similar dimensions to the deck entry point. Descending a short ladder, the three rescue crew entered the double bottom, testing the atmosphere as they progressed. Locating the casualty, one rescuer checked the casualty's condition whilst the remaining two rescuers prepared the rescue stretcher. When appropriate, the casualty was man handled onto and secured into a rescue stretcher, thereafter, manoeuvred through and out off the double bottom.

Plate 3: Casualty on Rescue Stretcher

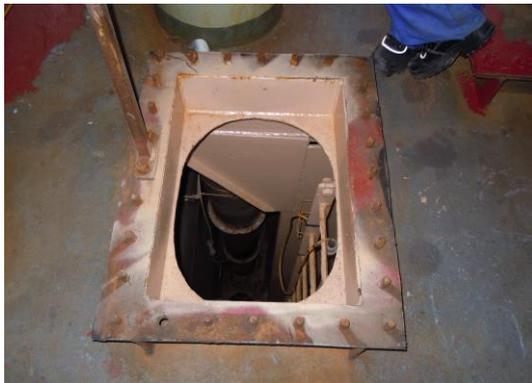
The No 4 tank is accessed via a raised rectangular bolted hatch located on the lower deck, incorporated into the hatch is a restrictive oval entrance, (measuring approximately 600mm by 400mm). This hatch allows the entrant to penetrate the tank by descending a fixed ladder to the steel floor of the upper compartment, access to the lower compartment is gained through a similar sized oval aperture, (which was slightly offset from the deck hatch), and second vertical fixed ladder.

Plate 4: Access to No 4 Tank from deck level

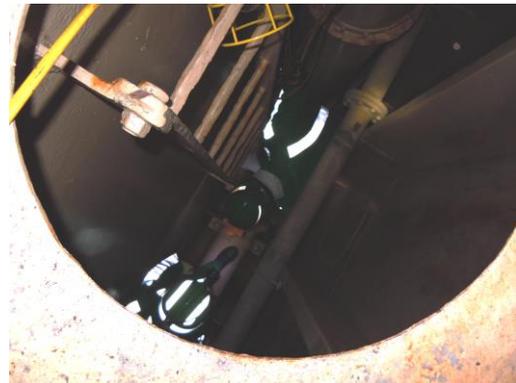
Lower compartment – 0.92m broad by 5m deep and is approximately 7m wide. Movement in the lower compartment was further restricted by a 300mm pipe (located 1.3m from the floor) and a 100mm pipe (located 4m from the floor), both pipes run across the compartment and were attached to bulkheads on opposite sides.

Plate 5: Access to Lower Compartment

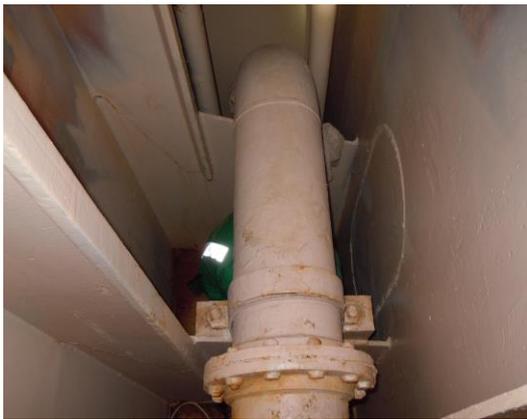
Plate 6: Casualty located under 300mm pipe

their were no height restrictions, the tripod was erected to full extension). The first two rescuers descended both ladders and located the casualty in the position identified (see plate 6).

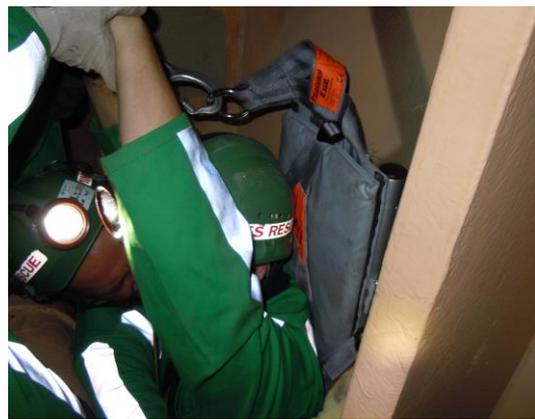
Plate 7: Rescuers attaching the casualty to stretcher

One rescuer climbed down to assisted the casualty from beneath the pipe whilst the second rescuer pulled the casualty upward and over the pipe. The prepared rescue stretcher, in the mean time, had been lowered via the winch from the deck into the lower compartment in preparation for transportation of the casualty. The rescue stretcher was then positioned behind the casualty and both rescuers secured the casualty to the stretcher in an upright position (plate 7).

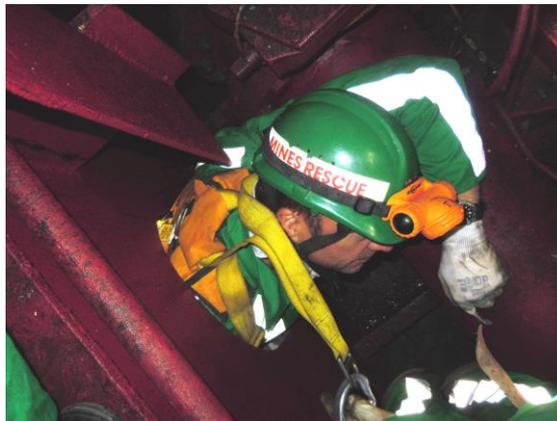
Plate 11: Harness fitted and casualty removed through lightning hole

A second member of the rescue crew then climbed into the bilge area and assisted with the horizontal removal of the casualty from the enclosed space (plate 11 & 12). Manually handling the casualty out of the enclosed space was made easier by having one rescuer inside and one rescuer outside of the enclosed space to receive the casualty. Having eased the casualty out of the enclosed space his harness was attached to the winch and slowly & carefully raised to the lower deck, (guided by both rescuers plate 13). At lower deck level, the casualty was laid onto and secured into the rescue stretcher in preparation for the next phase of the exercise (plate 14).

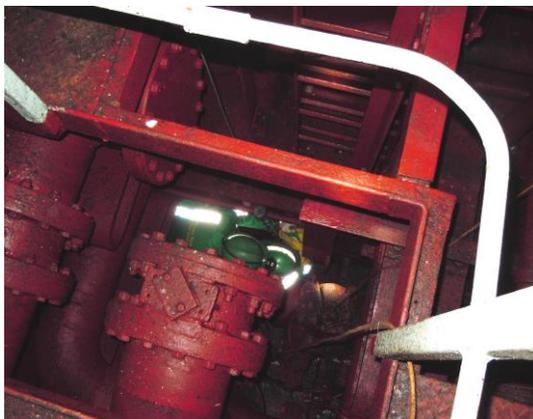
Plate 12: Casualty assisted out of bilge area

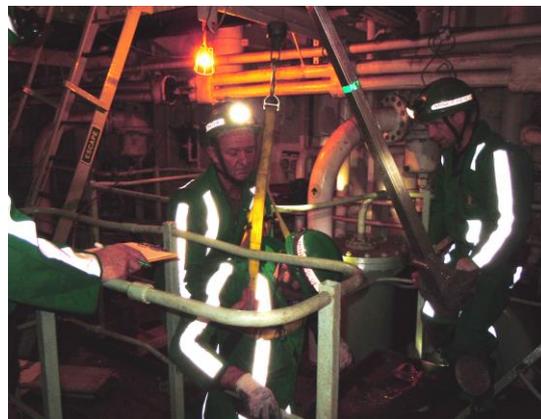
Plate 13: Casualty hoisted to Lower Deck level

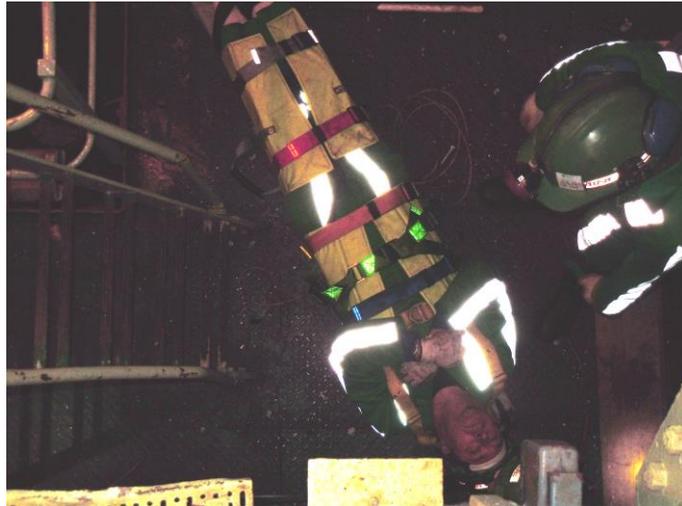
Plate 14: Casualty secured to rescue stretcher and prepared for lifting
